Compliance Report EPBC 2020-8717

Shark Bay Resources Dredging
15 August 2022 to 12 September 2022

Customer	Shark Bay Resources Pty Ltd
Project	158800.004
Deliverable	R-1588_00-12
Version	0
	7 December 2022

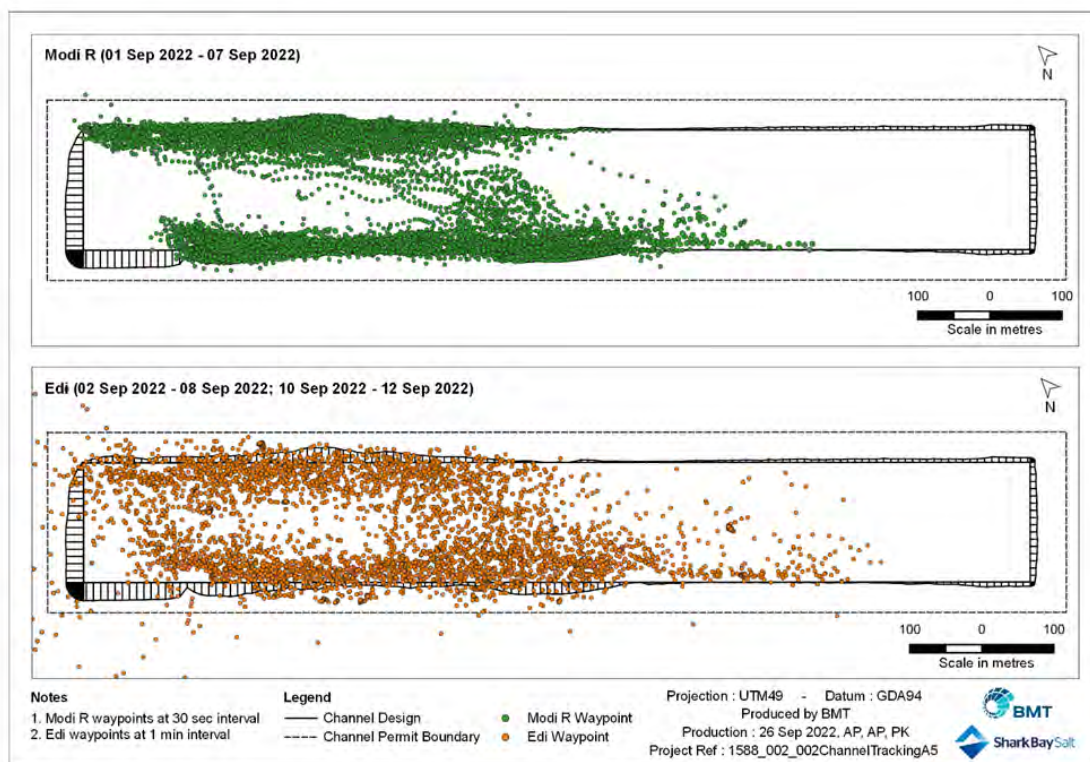
Figure 2.2 Modi R (top) and Edi (bottom) waypoints during dredging and seabed levelling of the Entrance Channel

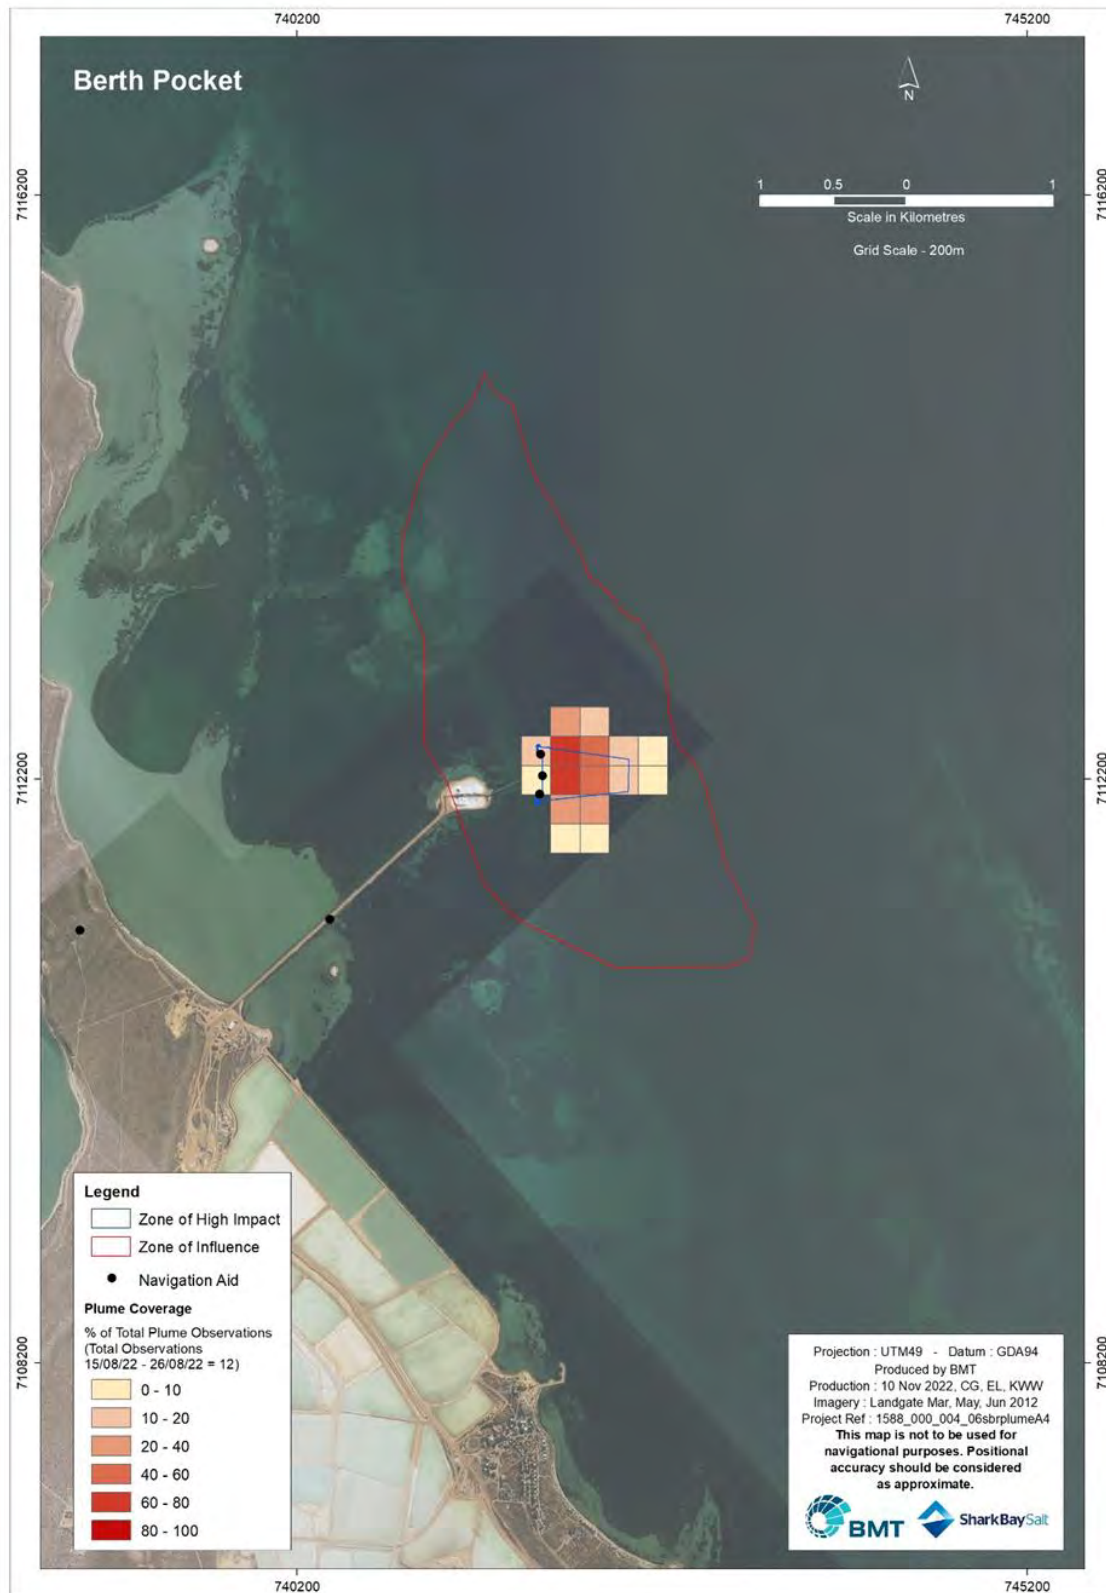
Figure 2.4 Plume coverage map of the seabed levelling operations in the Berth Pocket during the Useless Loop maintenance dredging campaign

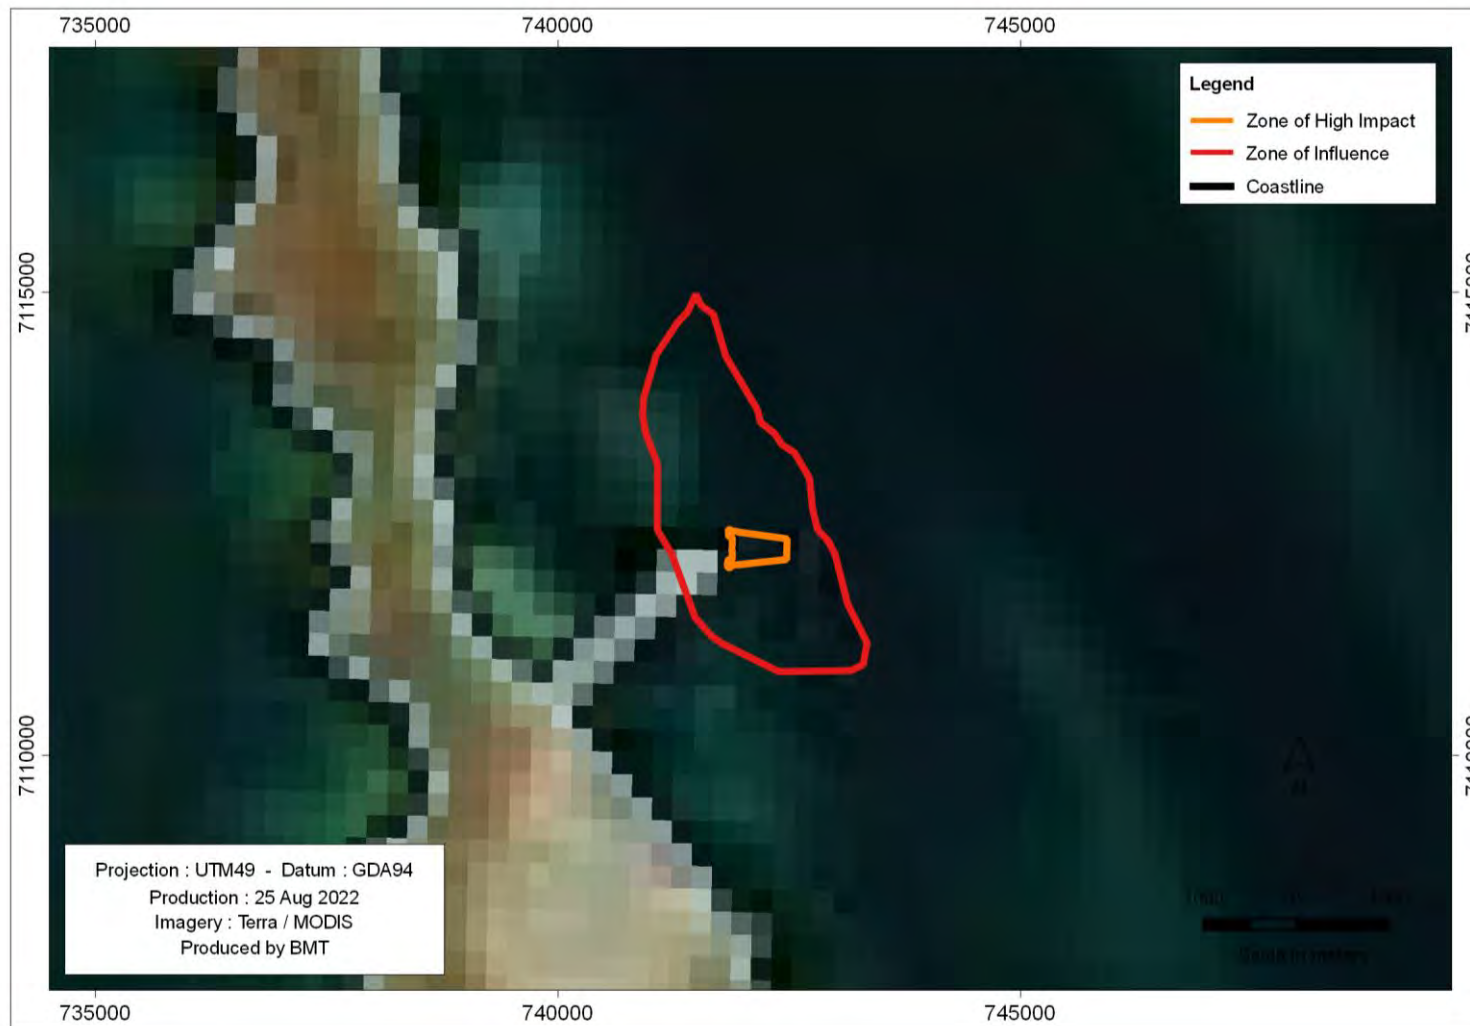
Figure 2.9 Terra-MODIS satellite imagery of the Berth Pocket captured during seabed levelling operations for the 2022 Useless Loop maintenance dredging campaign on 25 August 2022

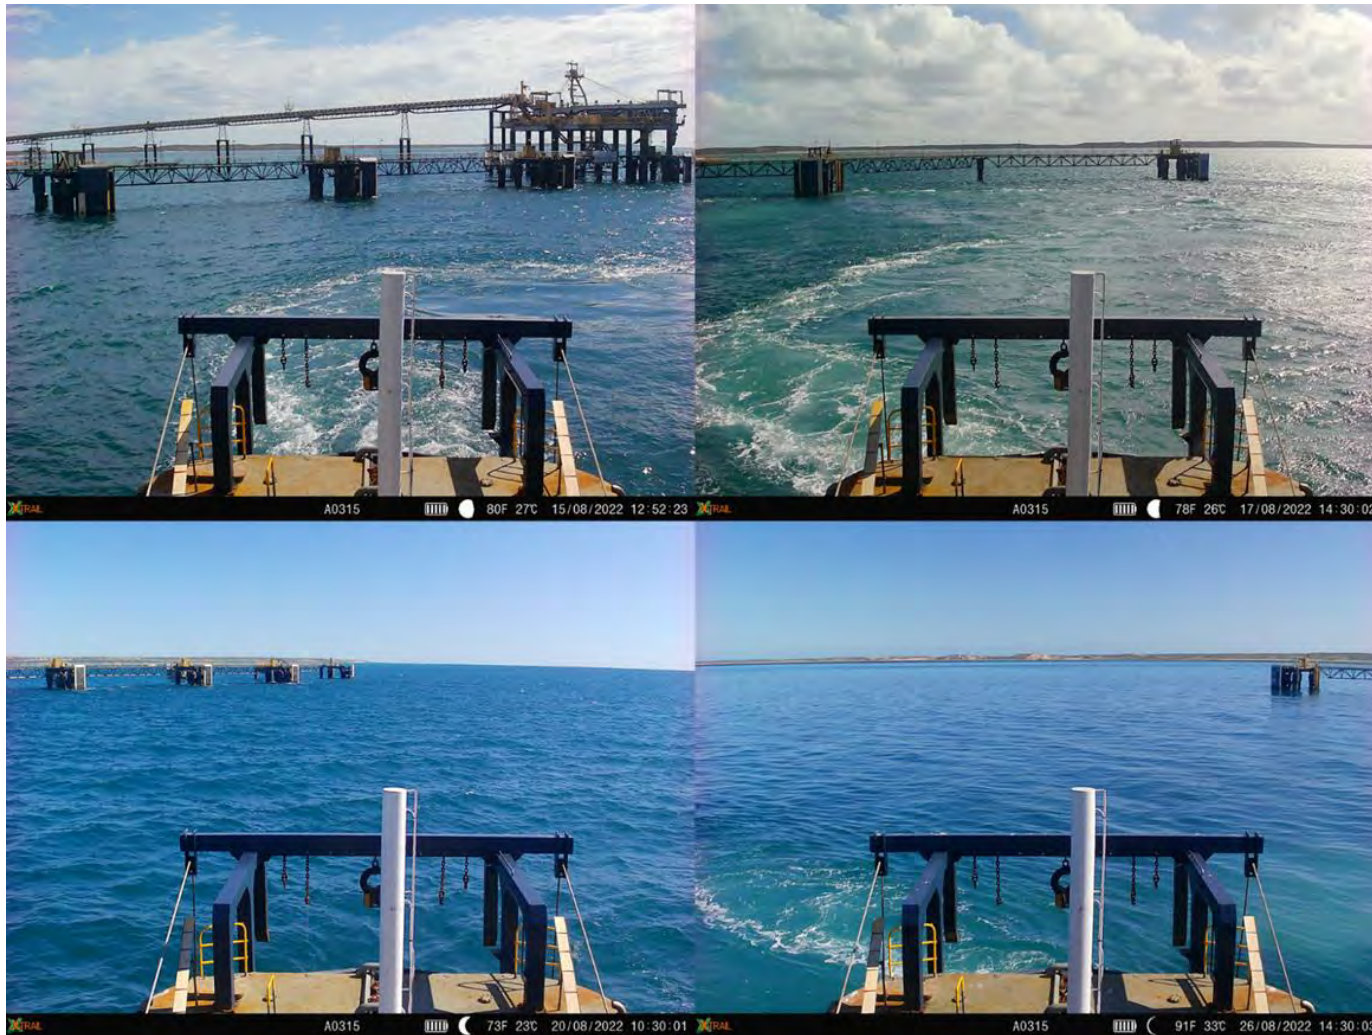
Remote imagery captured at the Berth Pocket indicates that turbid plumes surrounding the tug vessel were light in colour and often no turbid plume was observed at all. The small-scale localised turbid plumes that were observed behind the tug vessel dissipated within a distance of ~50–100 m (Figure 2.13). Similarly, the remote imagery captured from the tug vessel during seabed levelling operations in the Entrance Channel observed minimal turbid plumes surrounding or trailing behind the operation vessel (Figure 2.14). Where turbid plumes were observed in the Entrance Channel, they were typically in the vicinity of the operational dredge vessel. The remote imagery captured from the dredge vessel show trailing turbid plumes situated largely within the Entrance Channel which appear to dissipate within ~500–1000 m (Figure 2.15). The turbid plumes observed in the Disposal Area were more evenly dispersed compared to the linear trailing turbid plumes observed in the Entrance Channel (Figure 2.15). The reliability of the RIUs to capture the extent of turbid plumes generated from seabed levelling, dredging and disposal was often limited by the restricted field of view, low vantage point and/or sun glint on the water. However, monitoring data compared from RIU imagery, satellite imagery, and daily plume sketches, are well aligned and indicating they provide an accurate representation of plume coverage during the campaign.

Figure 2.13 Remote imagery captured during seabed levelling operations in the Berth Pocket as part of the 2022 Useless Loop maintenance dredging campaign on 15 August 2022 (top left), 17 August 2022 (top right), 20 August 2022 (bottom left) and 25 August 2022 (bottom right).

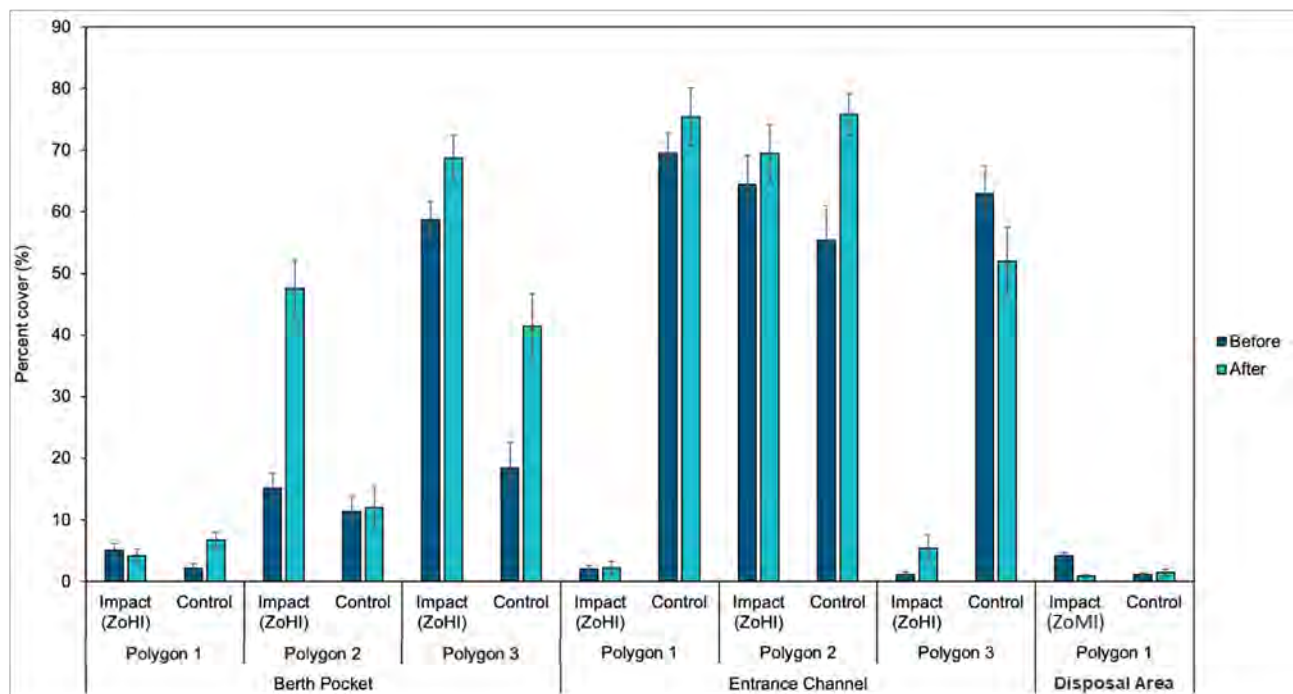
With the exception of impact (ZoHI) sites at Berth Pocket Polygon 1 and Impact (ZoMI) Disposal Area Polygon 1, higher seagrass cover was observed across the remaining polygon pairs after dredging operations (Figure 2.25). Lower seagrass cover was observed after dredging operations at impact sites Berth Pocket Polygon 1 and Disposal Area Polygon 1 (Figure 2.25).

Figure 2.25 Seagrass cover (%; mean ± SE) for each paired polygon within Berth Pocket, Entrance Channel and Disposal Area across time (before and after)

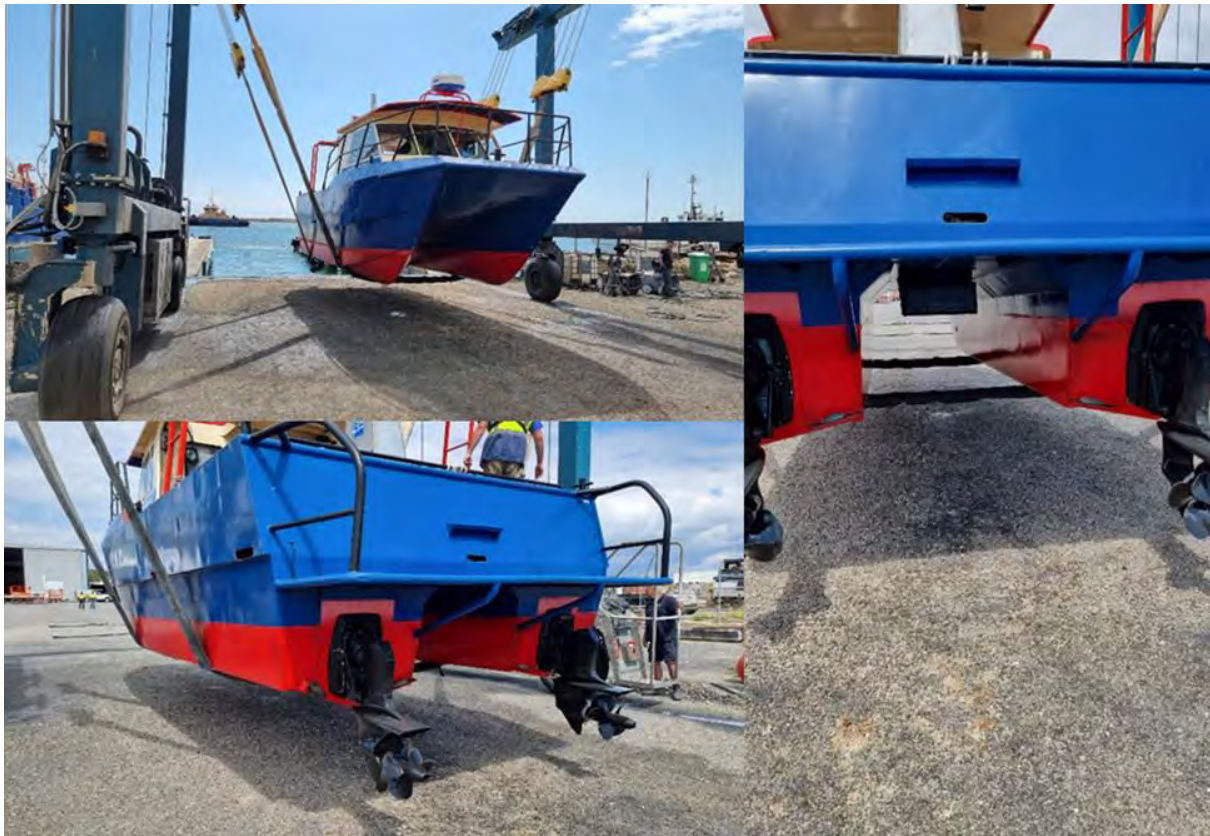
Figure 2.27 Images of the hull of hydrographic survey vessel Rind-R showing newly applied anti-foulant coating prior to launch at Carnarvon, Western Australia

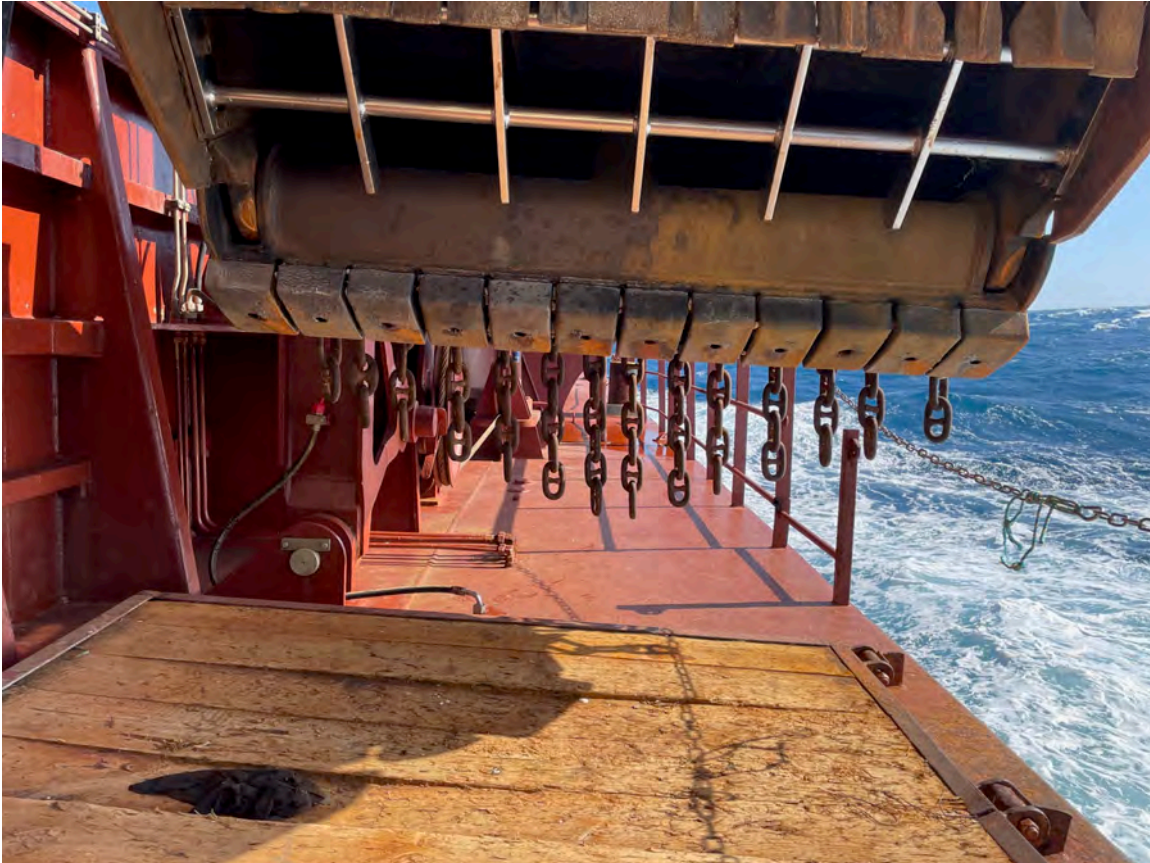
Figure 5: Photograph of the “Sea Turtle Deflector” attached to Modi R draghead
