Annual Compliance Report EPBC 2020-8717

Shark Bay Resources Dredging
15 August 2022 to 14 August 2023

Dredging Environment Management Plan Implementation: Environmental Close Out Report

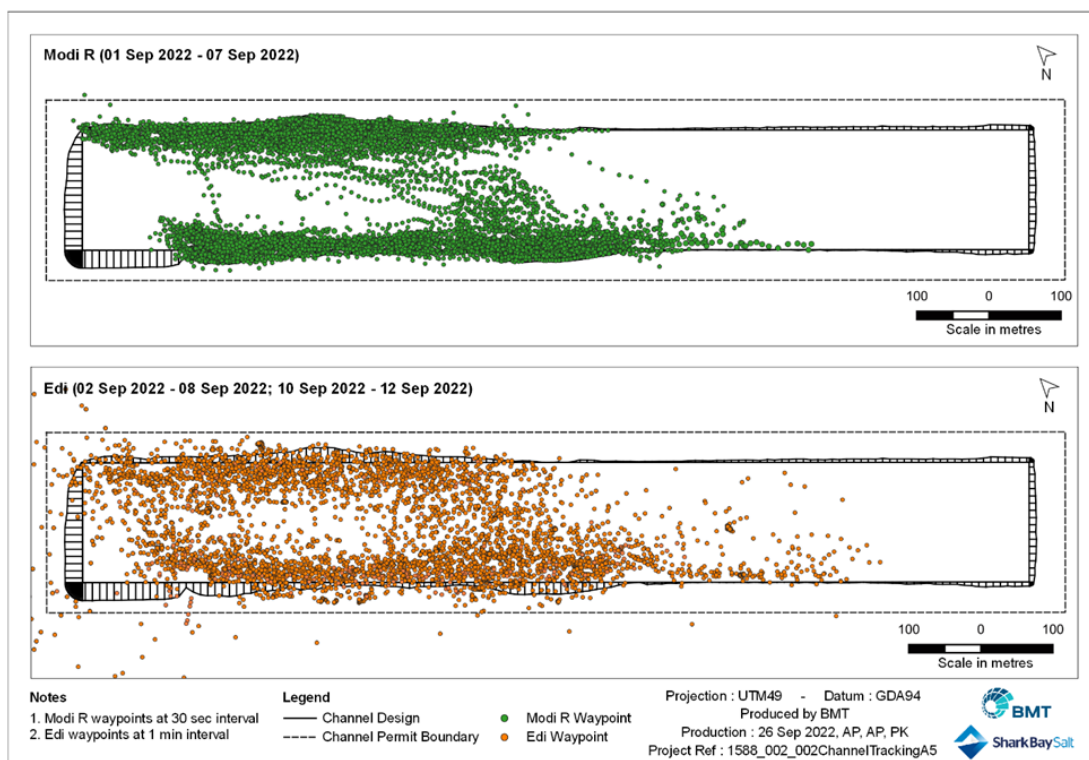
Figure 2.2 Modi R (top) and Edi (bottom) waypoints during dredging and seabed levelling of the Entrance Channel

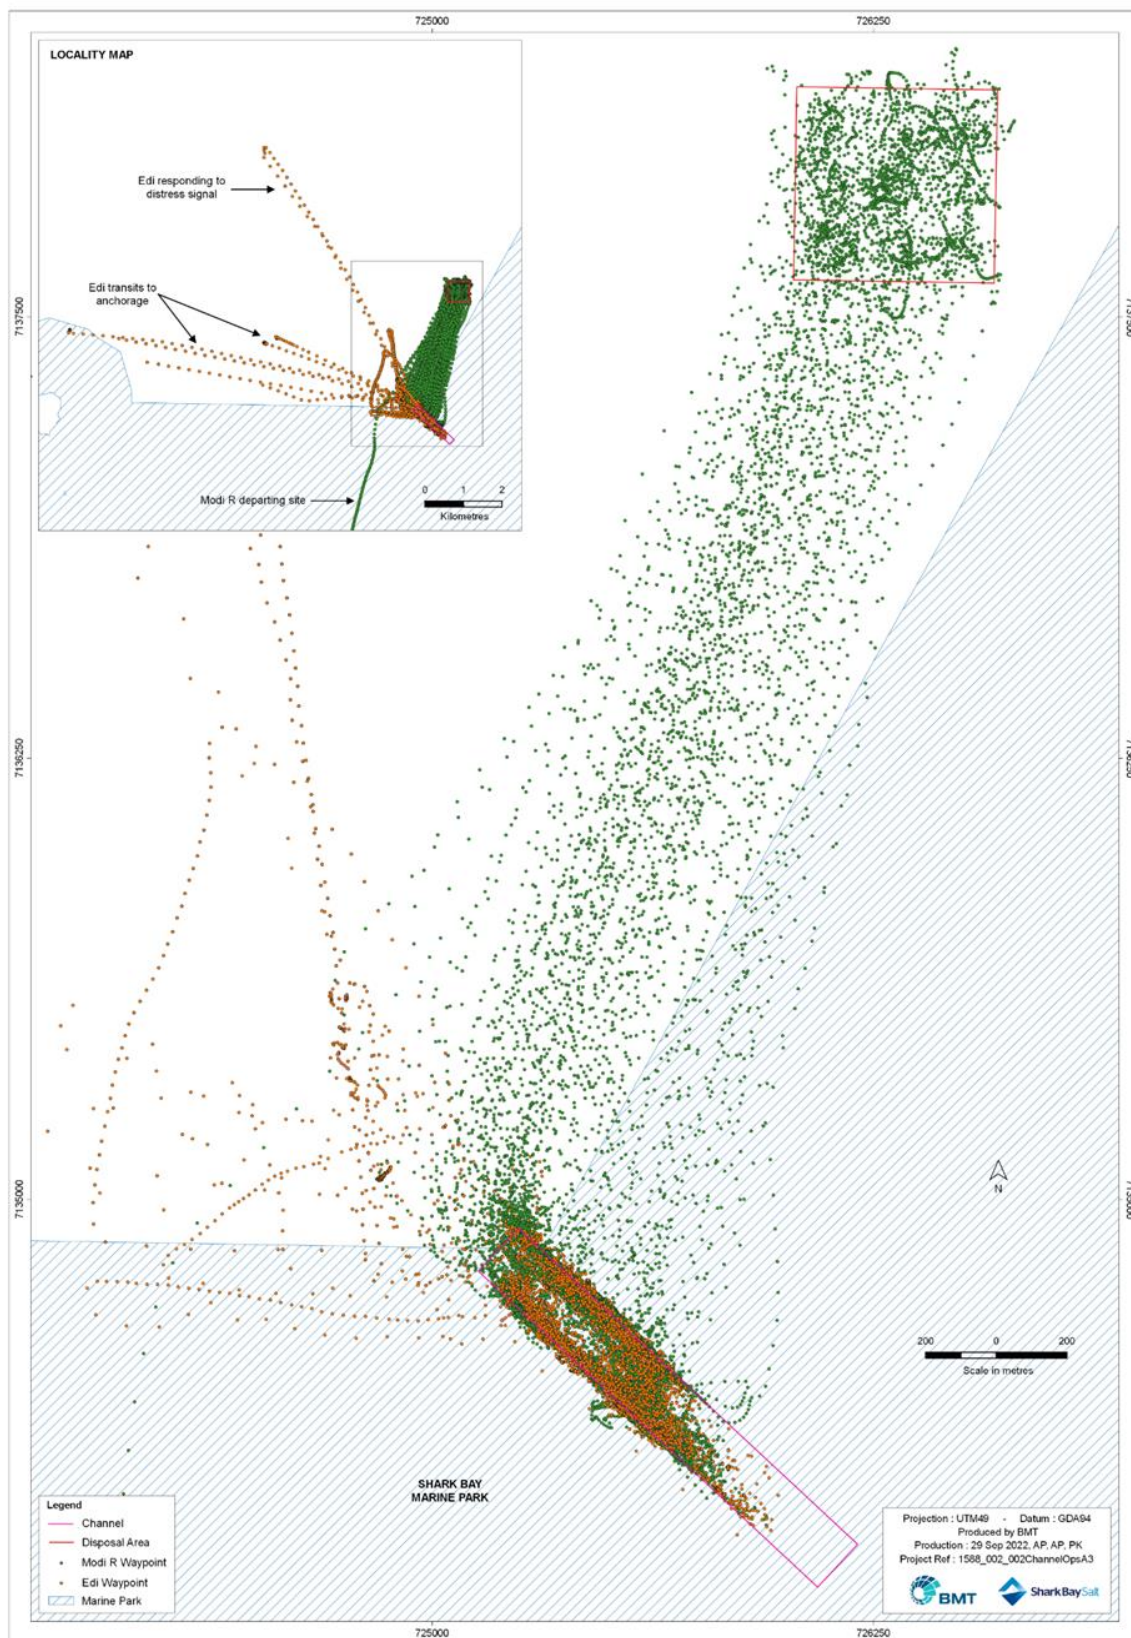
Figure 2.3 Modi R and Edi waypoints during dredging and seabed levelling of the Entrance Channel and disposal at the Disposal Area.

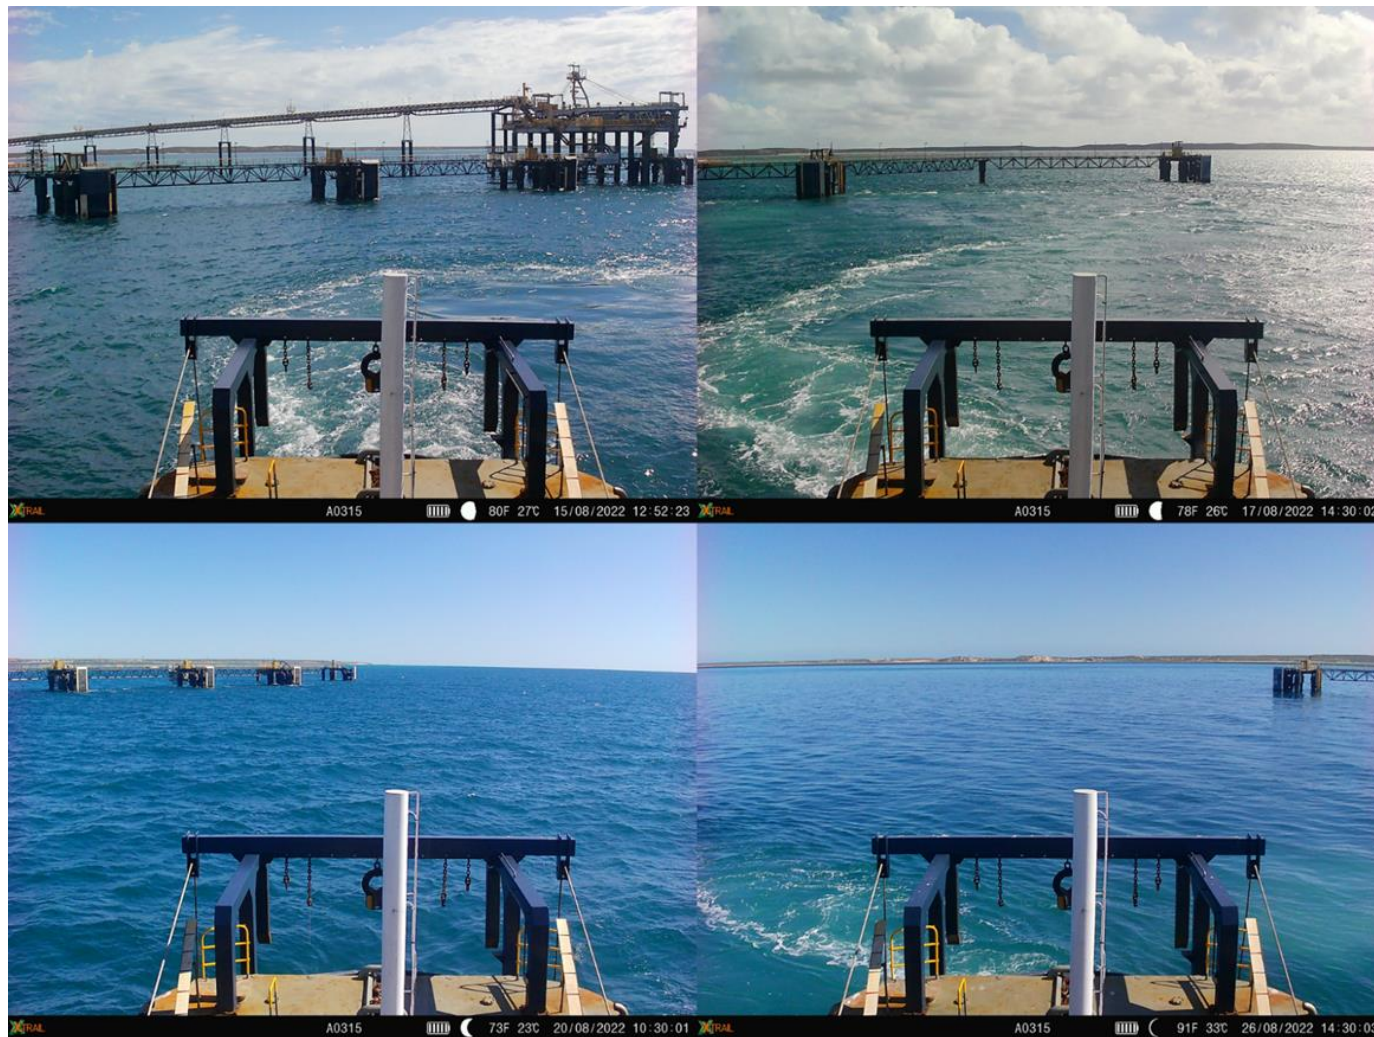
Figure 2.13 Remote imagery captured during seabed levelling operations in the Berth Pocket as part of the 2022 Useless Loop maintenance dredging campaign on 15 August 2022 (top left), 17 August 2022 (top right), 20 August 2022 (bottom left) and 25 August 2022 (bottom right).

Remote imagery captured at the Berth Pocket indicates that turbid plumes surrounding the tug vessel were light in colour and often no turbid plume was observed at all. The small-scale localised turbid plumes that were observed behind the tug vessel dissipated within a distance of ~50–100 m (Figure 2.13). Similarly, the remote imagery captured from the tug vessel during seabed levelling operations in the Entrance Channel observed minimal turbid plumes surrounding or trailing behind the operation vessel (Figure 2.14). Where turbid plumes were observed in the Entrance Channel, they were typically in the vicinity of the operational dredge vessel. The remote imagery captured from the dredge vessel show trailing turbid plumes situated largely within the Entrance Channel which appear to dissipate within ~500–1000 m (Figure 2.15). The turbid plumes observed in the Disposal Area were more evenly dispersed compared to the linear trailing turbid plumes observed in the Entrance Channel (Figure 2.15). The reliability of the RIUs to capture the extent of turbid plumes generated from seabed levelling, dredging and disposal was often limited by the restricted field of view, low vantage point and/or sun glint on the water. However, monitoring data compared from RIU imagery, satellite imagery, and daily plume sketches, are well aligned and indicating they provide an accurate representation of plume coverage during the campaign.

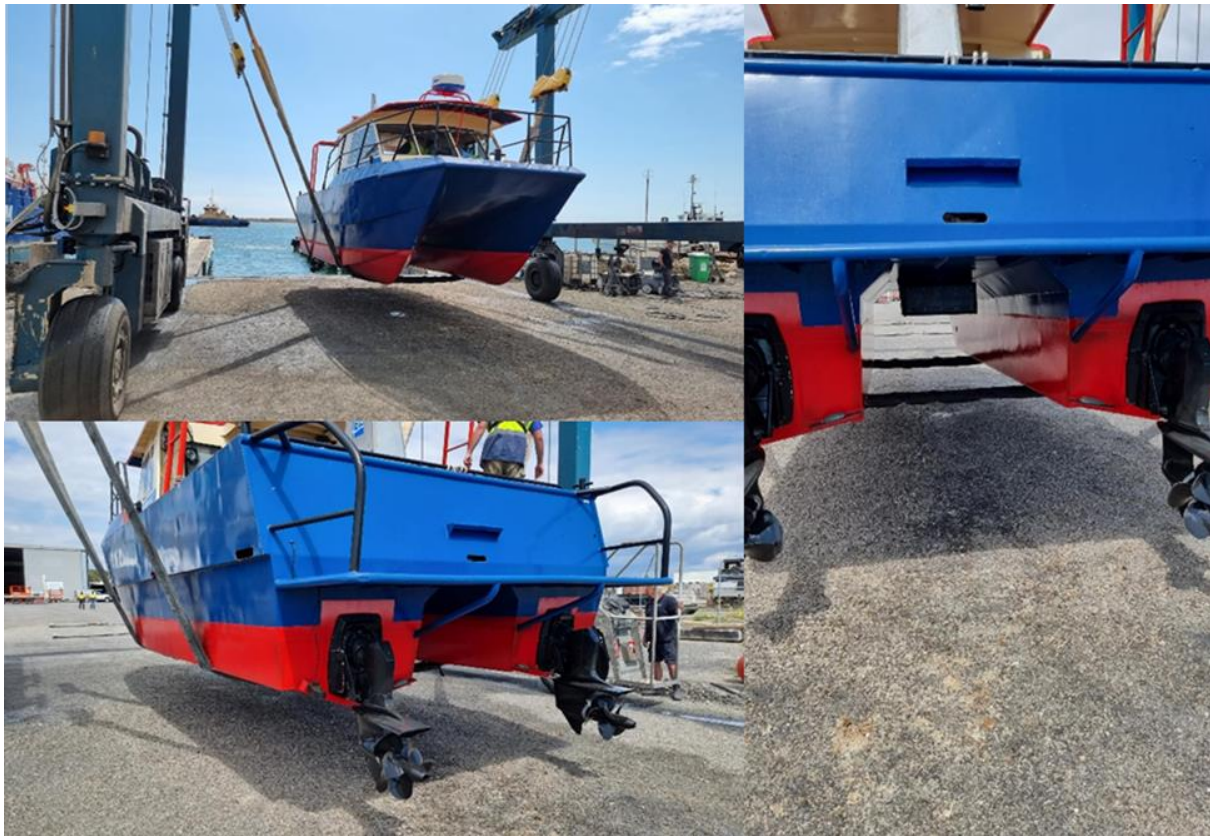
Figure 2.27 Images of the hull of hydrographic survey vessel Rind-R showing newly applied anti-foulant coating prior to launch at Carnarvon, Western Australia

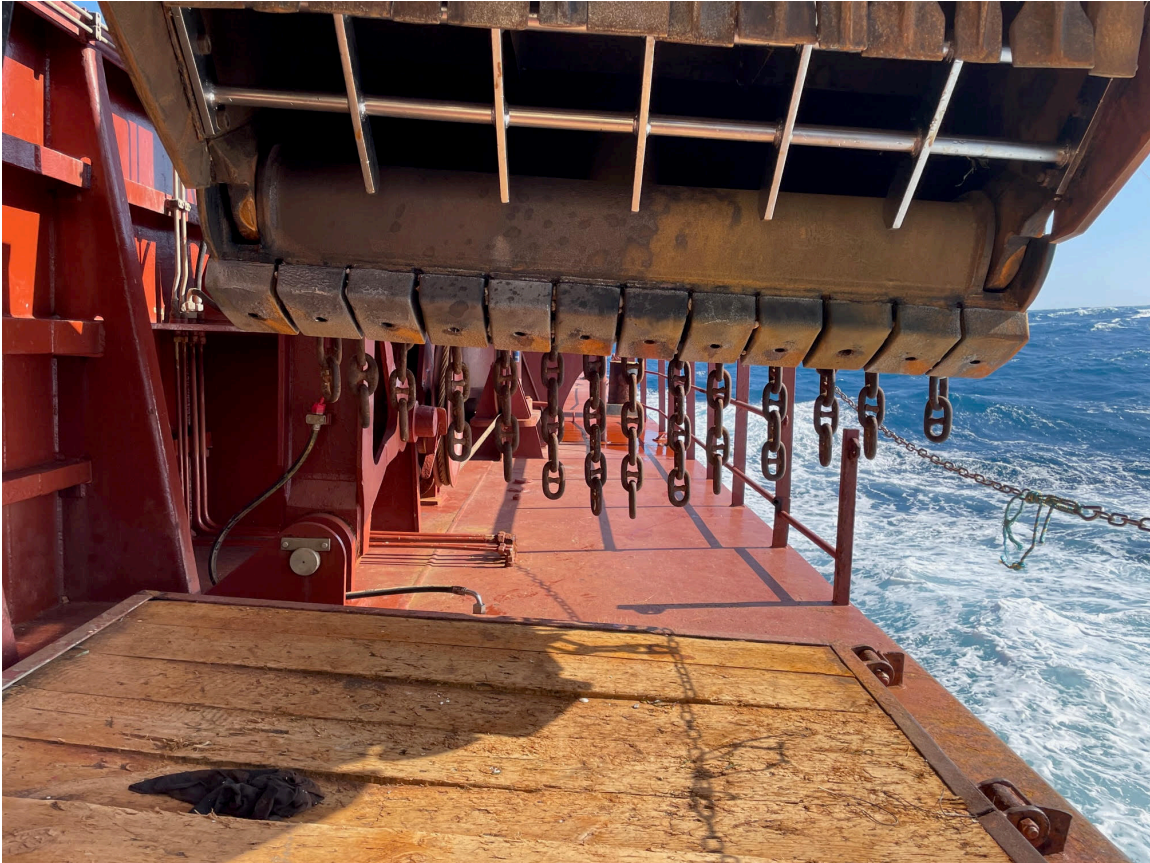
Figure 5: Photograph of the “Sea Turtle Deflector” attached to Modi R draghead
