# Annual Compliance Report EPBC 2020-8717

Shark Bay Resources Dredging  
15 August 2023 to 14 August 2024

Shark Bay Resources Pty Ltd  
158800.004  
R-003455.000-1  
0  
22 November 2024

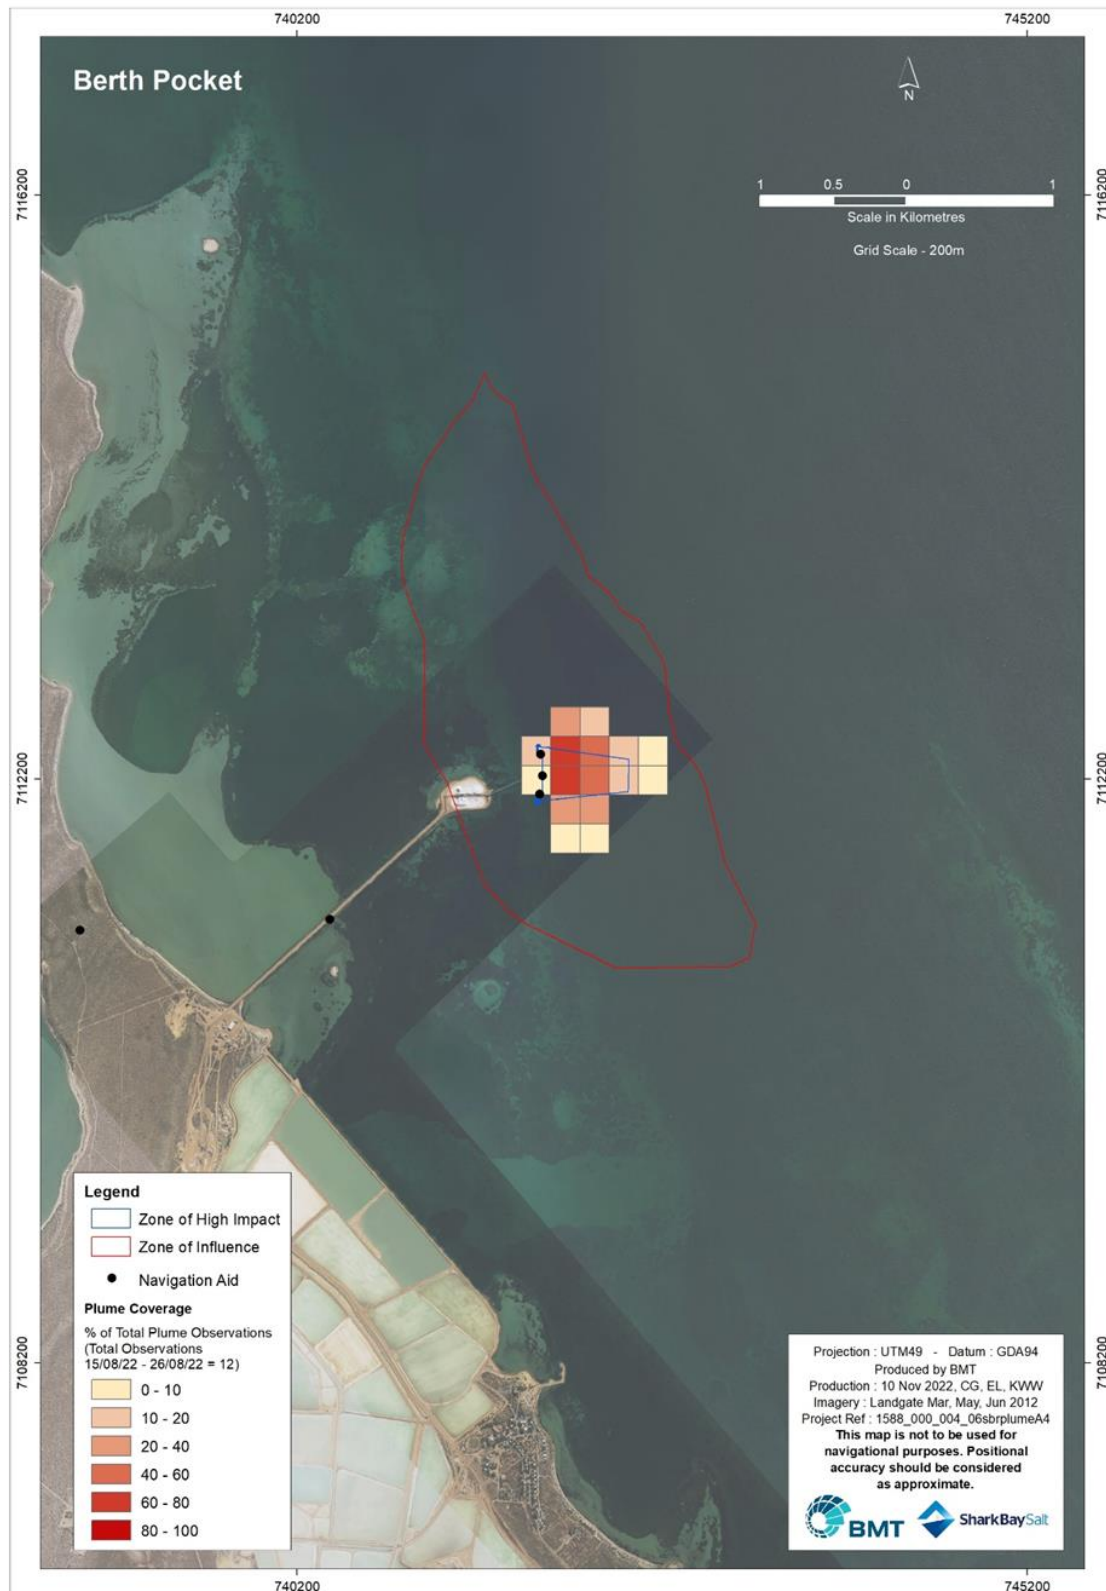
Figure 2.4 Plume coverage map of the seabed levelling operations in the Berth Pocket during the Useless Loop maintenance dredging campaign

It is recognised that the reliability of plume sketches can be limited by the distance over which personnel from a low vantage point can see turbidity in the water. Therefore, site photographs (Section 2.2.2) and remote Imagery (Section 2.2.3) were collected to verify the plume coverage map (Figure 2.4 and Figure 2.5). Based on these data, the plume coverage map is considered to provide an accurate representation of plume coverage during the campaign.

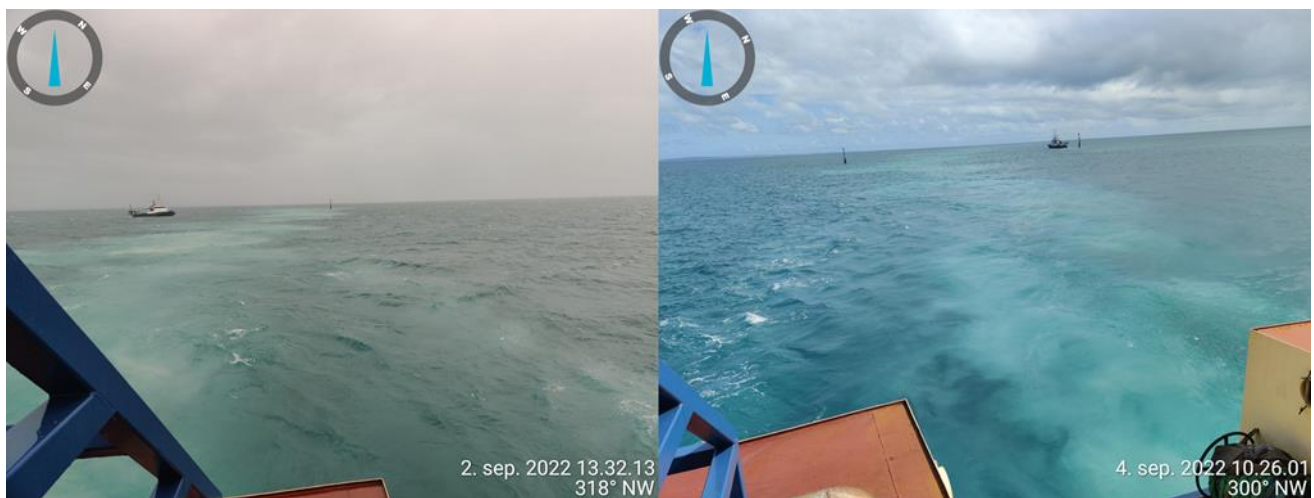
Figure 2.7 Site photographs of dredging operations in the Entrance Channel captured during the 2022 Useless Loop maintenance dredging campaign on 02 September 2022 (Left) and 04 September 2022 (Right)

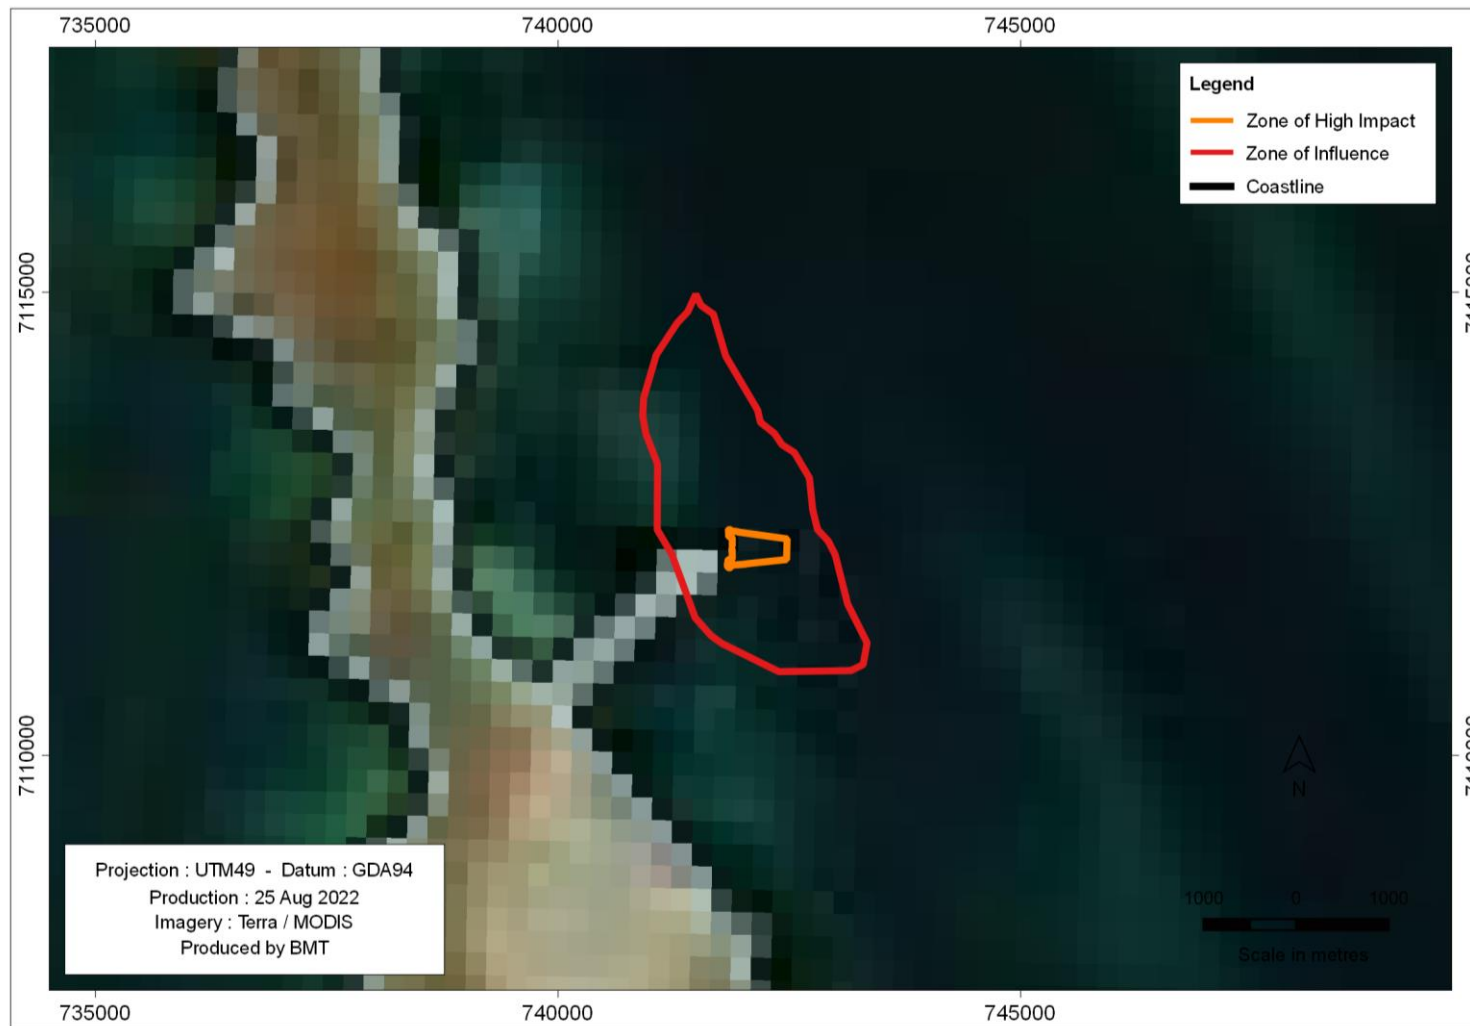
Figure 2.9 Terra-MODIS satellite imagery of the Berth Pocket captured during seabed levelling operations for the 2022 Useless Loop maintenance dredging campaign on 25 August 2022

In accordance with the DEMP (BMT 2021a), satellite imagery was captured and reviewed daily to assist with confirming the extent of the visual plume. Imagery from the Aqua and Terra MODIS satellites was reviewed and the image with greatest clarity and/or least cloud obstruction was selected for environmental monitoring. There was no discernible plume observed in aqua or terra satellite imagery throughout the entirety of the maintenance dredging Campaign. The relatively small-scale plumes generated by seabed levelling, dredging and disposal activities during the Campaign were likely too fine to be observed within MODIS satellite imagery. Throughout the campaign, cloud cover obscured 100% of the project area on 3 out of 12 operational days during seabed levelling at the Berth Pocket and 4 out of 11 operational days during seabed levelling, dredging and disposal activities at the Entrance Channel and Disposal Area (~30% of images obscured overall). Example satellite imagery for each operational area which was not obstructed by cloud cover are provided in Figure 2.9 and Figure 2.10.

Remote imagery captured at the Berth Pocket indicates that turbid plumes surrounding the tug vessel were light in colour and often no turbid plume was observed at all. The small-scale localised turbid plumes that were observed behind the tug vessel dissipated within a distance of ~50–100 m (Figure 2.13). Similarly, the remote imagery captured from the tug vessel during seabed levelling operations in the Entrance Channel observed minimal turbid plumes surrounding or trailing behind the operation vessel (Figure 2.14). Where turbid plumes were observed in the Entrance Channel, they were typically in the vicinity of the operational dredge vessel. The remote imagery captured from the dredge vessel show trailing turbid plumes situated largely within the Entrance Channel which appear to dissipate within ~500–1000 m (Figure 2.15). The turbid plumes observed in the Disposal Area were more evenly dispersed compared to the linear trailing turbid plumes observed in the Entrance Channel (Figure 2.15). The reliability of the RIUs to capture the extent of turbid plumes generated from seabed levelling, dredging and disposal was often limited by the restricted field of view, low vantage point and/or sun glint on the water. However, monitoring data compared from RIU imagery, satellite imagery, and daily plume sketches, are well aligned and indicating they provide an accurate representation of plume coverage during the campaign.

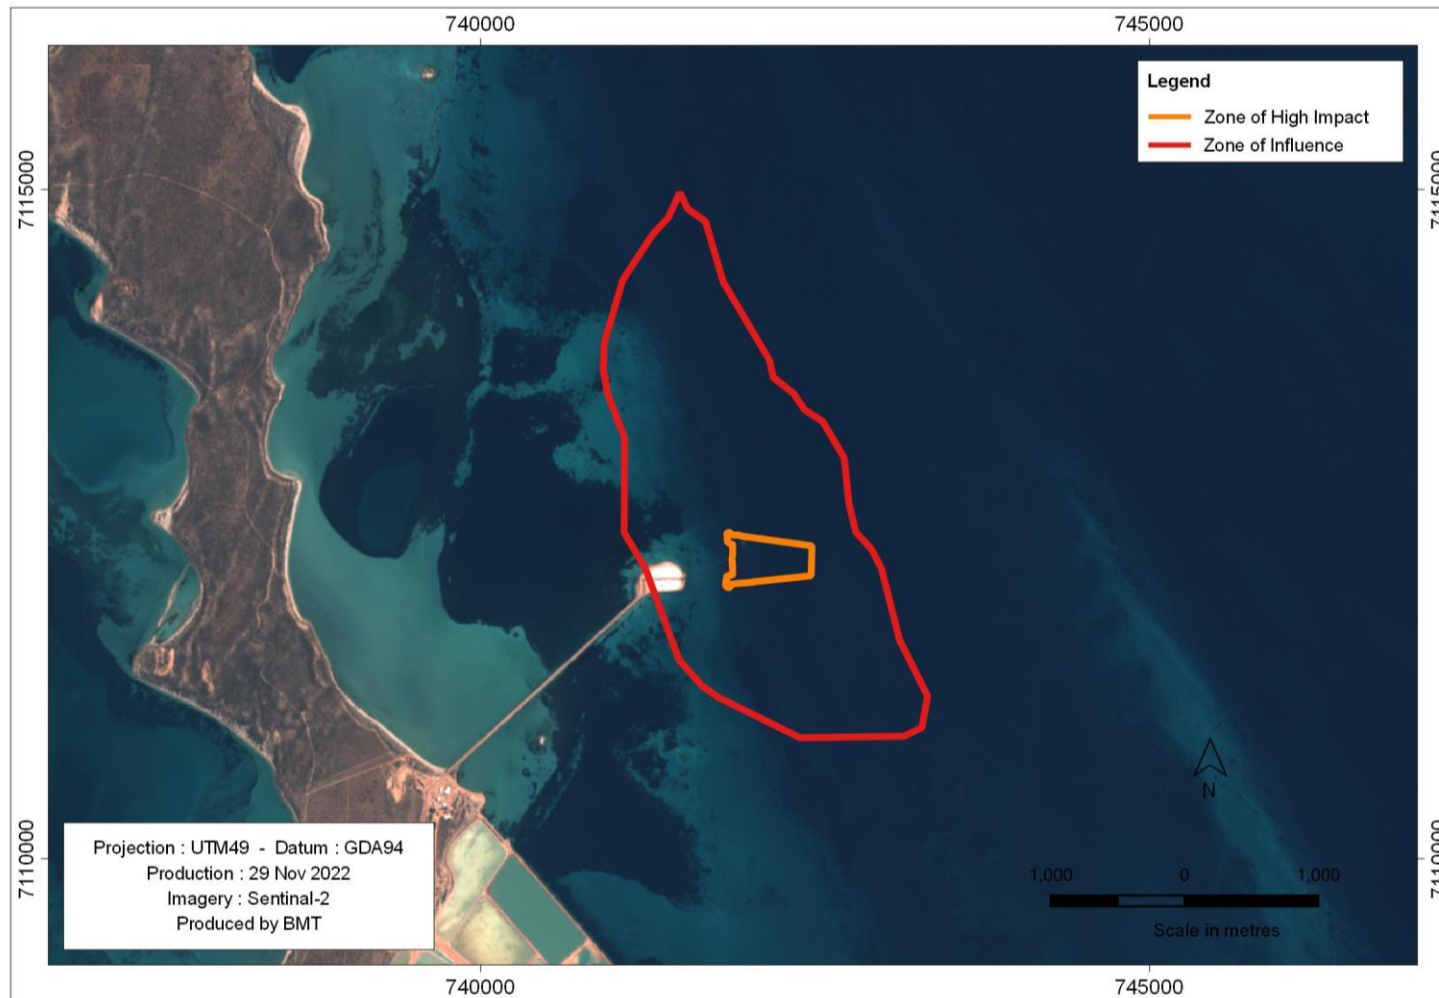
Figure 2.11 Sentinel-2 satellite imagery of the Berth Pocket captured during seabed levelling operations for the 2022 Useless Loop maintenance dredging campaign on 25 August 2022.

Following the completion of the campaign, high-resolution (10 m/pixel) Sentinel-2 satellite imagery from Copernicus Sentinel 2A data was assessed to further validate existing visual plume observation data. The sentinel-2 satellite imagery captured 25 August 2022 during seabed levelling at the Berth Pocket indicates a minor turbid plume contained entirely within the ZoHI (Figure 2.11). Similarly, the sentinel-2 satellite imagery captured 04 September 2022 during seabed levelling, dredging and disposal operations at the Entrance Channel and Disposal Area show that existing turbid plumes remained within the predicted extents as outlined in the EIA (Figure 2.12). The improved resolution of these satellite images provides additional confidence to the accuracy of the plume sketches and site photographs collected on the respective dates at each location.

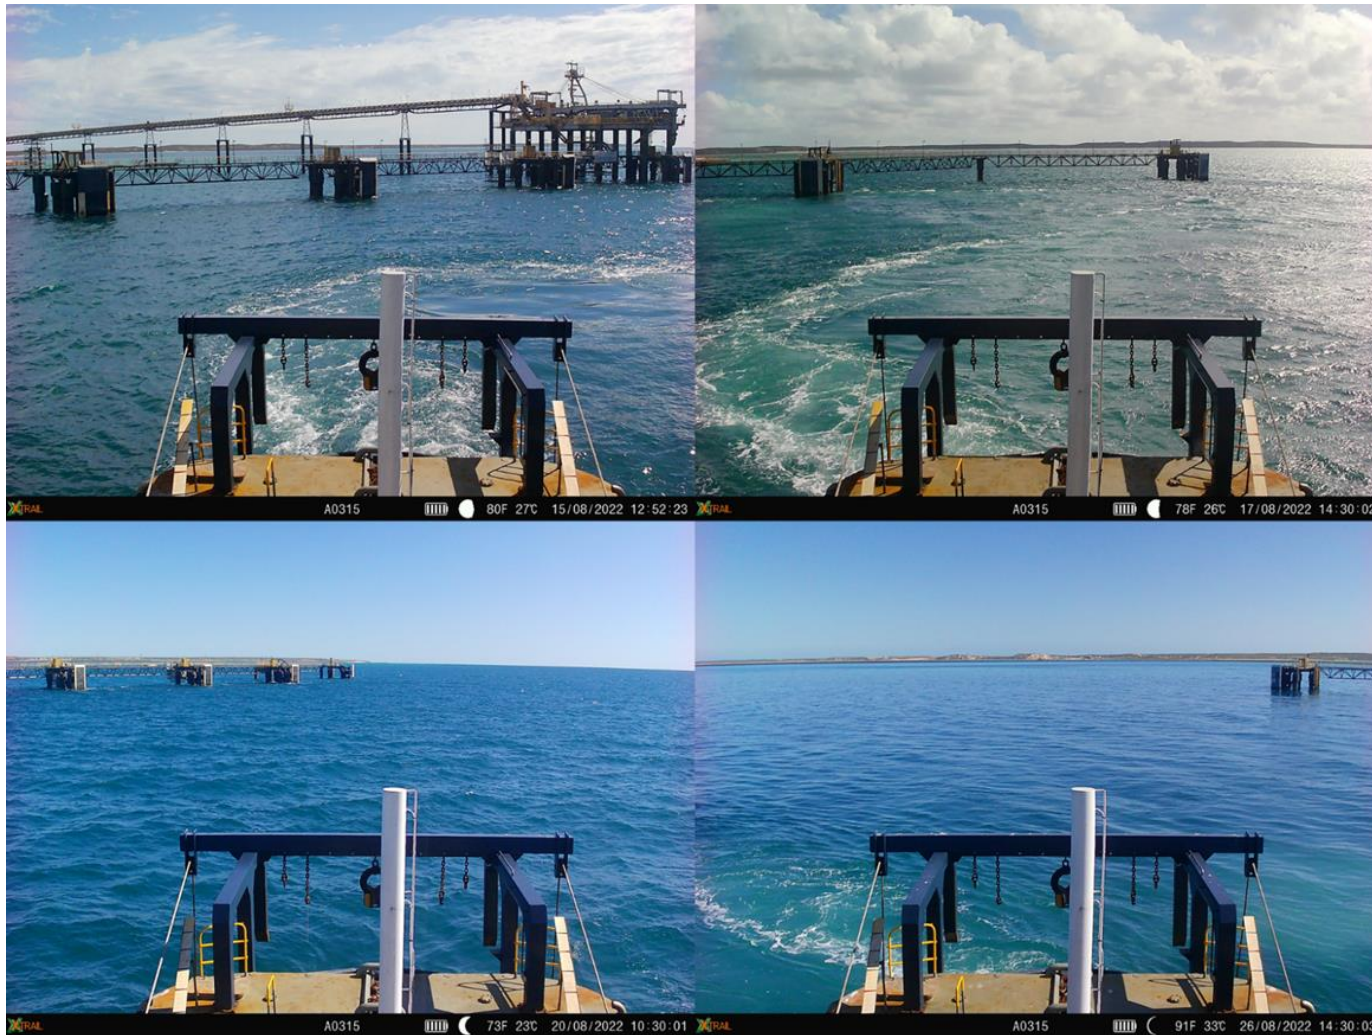
Figure 2.13 Remote imagery captured during seabed levelling operations in the Berth Pocket as part of the 2022 Useless Loop maintenance dredging campaign on 15 August 2022 (top left), 17 August 2022 (top right), 20 August 2022 (bottom left) and 25 August 2022 (bottom right).

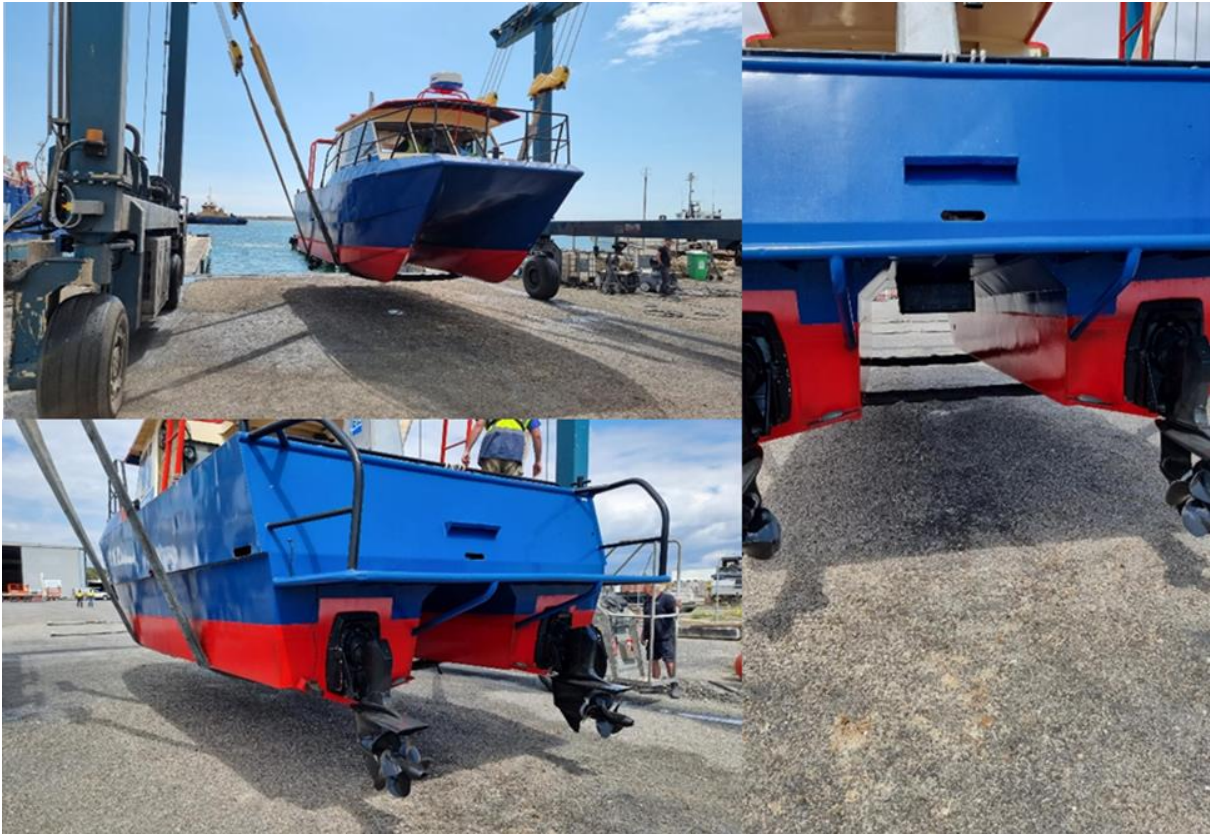
Figure 2.27 Images of the hull of hydrographic survey vessel Rind-R showing newly applied anti-foulant coating prior to launch at Carnarvon, Western Australia

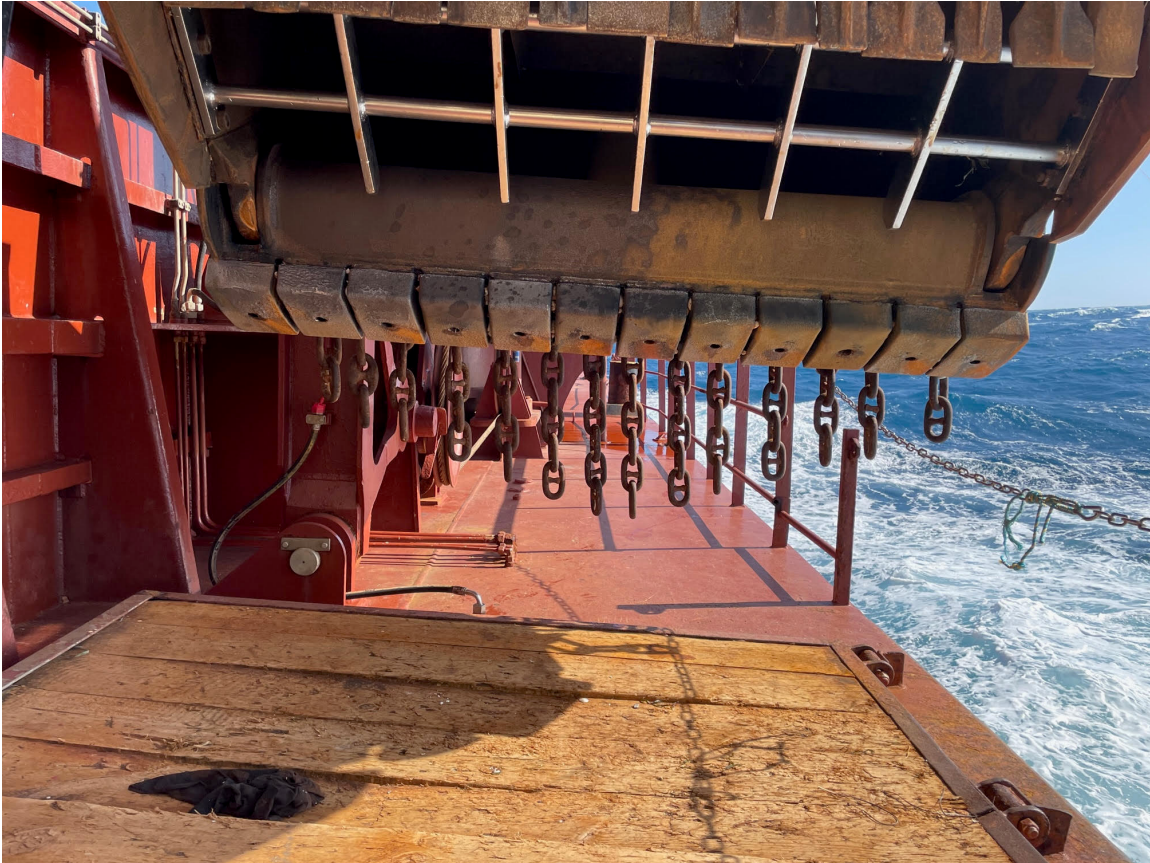
Figure 5: Photograph of the “Sea Turtle Deflector” attached to Modi R draghead
